Using LiDAR-derived DEM's to delineate and characterize landslides in Northern Kentucky and Hamilton County, Ohio

Jesse Amundsen^{a,*}, Sarah Johnson^a, Katie Rouse^a, Hongmei Wang^b

^a *Department of Physics and Geology, Northern Kentucky University, Highland Heights, KY 41015*

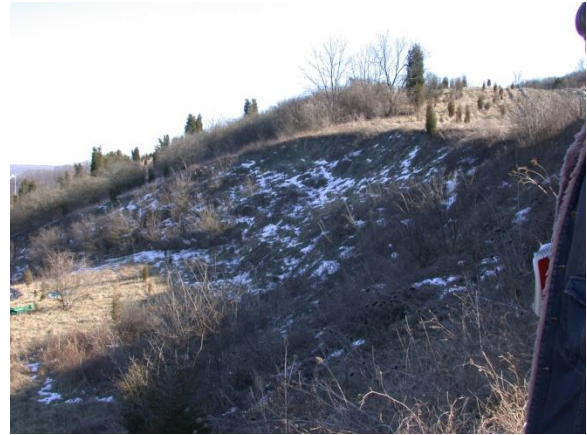
Figure 3: The River Rd. landslide as viewed from the northwest (Photo by Sarah Johnson).

Found off of River Rd. in Ft. Thomas, Kentucky is an active landslide that developed after the construction of the I-275 beltway that resides directly behind the slope that the landslide is affecting. The landslide is primarily occurring in a thick layer of fill deposited during construction of the expressway, but appears to be propagating through the bedrock which lies beneath River Rd. Few landslides in the region are as well-defined as the River Rd. landslide due to its sizable head scarp and characteristic bulge. From the surface, the landslide is easily observed as a rotational landslide (Figure 3).

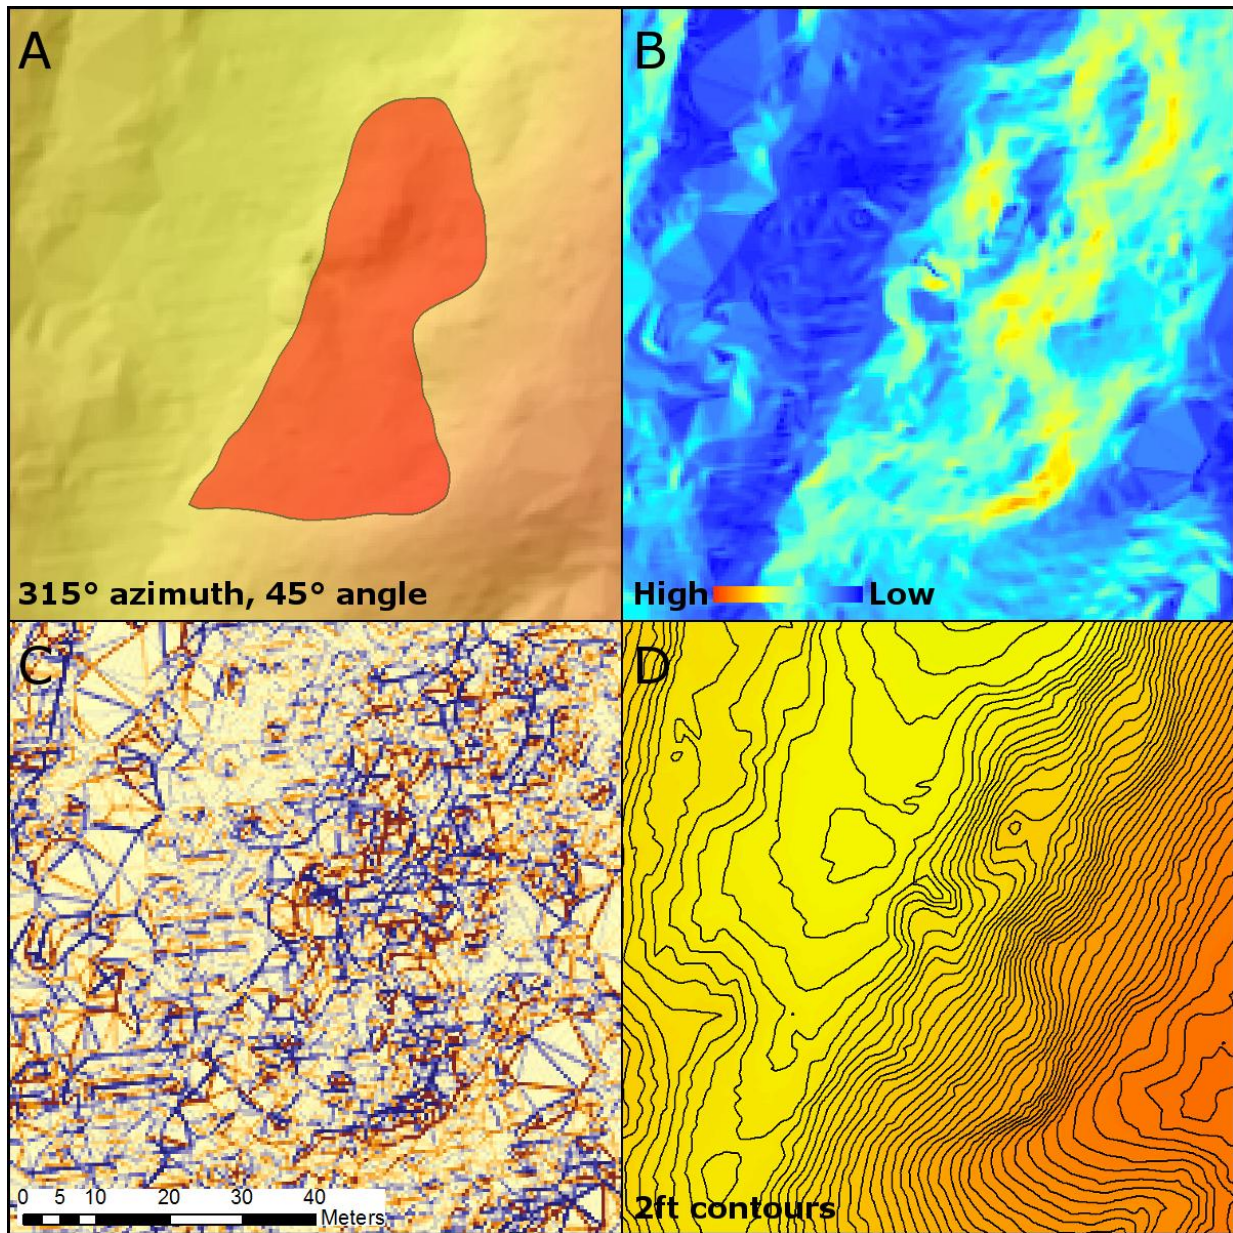
Figure 6: Composite display of four different topographic derivative maps of a newly discovered rotational landslide off of Lawyers Pt. in Anderson, OH that is believed to have occurred in lakebed clays. (A) Hillshade map generated with an azimuth of 315° and a sun angle of 45° draped over a bare earth DEM. The estimated extent of the landslide is highlighted in red. (B) Slope map showing areas of high slope angle in warmer colors (reds, oranges, yellows) and areas of low slope angle in cooler colors (greens, blues). There are a series of three features that appear to resemble head scarps of rotational landslides. Two of these features were confirmed in the field, but the third may have been caused by the unsmoothed TIN. (C) Curvature map showing areas of high curvature in warmer colors (reds, oranges) and areas of low curvature in cooler colors (blues). There is a weak but observable correlation between a clustering of low curvature values where the landslide toes are located. (D) Contour map generated with a 2ft contour spacing.

What appeared to be head scarps were identified on hillshade, slope, and contour maps (Figure 6A; Figure 6B; Figure 6D). The ground strike density of the surrounding area caused the curvature map to be unhelpful, though a weak pattern of clustering of high to low values is seen on the affected area much like for the Delhi Pike landslide in Ohio (Figure 6C). Field observation confirmed that the features were landslides, though they appeared inactive at present and trees were observed growing on them that were at least 45 to 50 years in age (Figure 7). It is unclear why the slides developed on a relatively low slope. The housing development had likely not begun when the slope initially failed which ruled out loading from development. While exploring the stream adjacent to the property lakebed clays were discovered in the channel (Figure 8). It is likely that movement of the plastic lakebed clays out of the slope led to the development of the landslides.

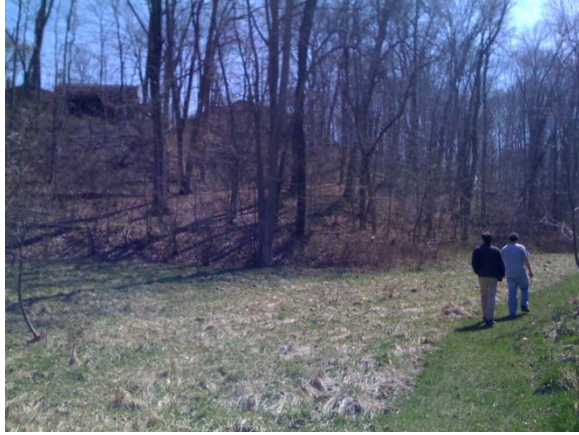
Figure 7: Trees growing vertically on top of the Lawyers Pt. landslide suggest that it is an older slide (Photo by Sarah Johnson).

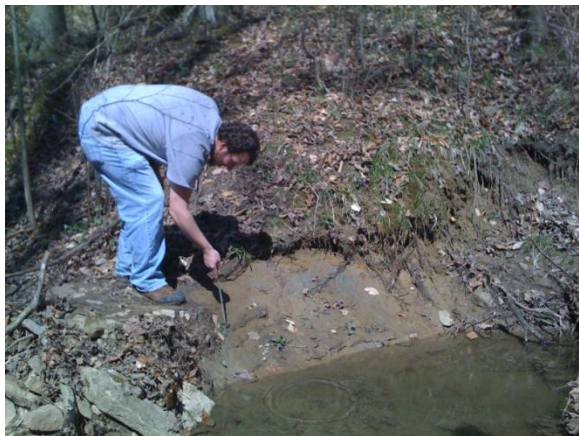
Figure 8: On the opposite side of the valley where the Lawyers Pt. landslide occurred was a stream that had exposed lakebed clays seen here in their dark grey and blue (Photo by Sarah Johnson).

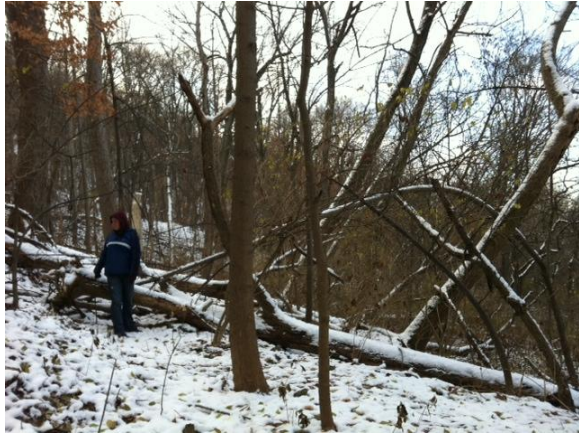
Figure 9: Trees located on the north-facing slope that parallels KY-8 near the Kenton and Boone county borders. The presence of both tilted and straight trees suggests that the numerous small rotational failures vary in age by at least 30 years (Photo by Sarah Johnson).

Field work confirmed the presence of multiple slides. Rather than a series of large consecutive landslides, the slope appeared to contain many smaller rotational slump failures. The presence of trees growing both at an angle and straight upwards suggests that these small rotational failures are separated by at least 30 years (Figure 9). Many of the slides continue through the road and have caused it to deform and crack (Figure 10).

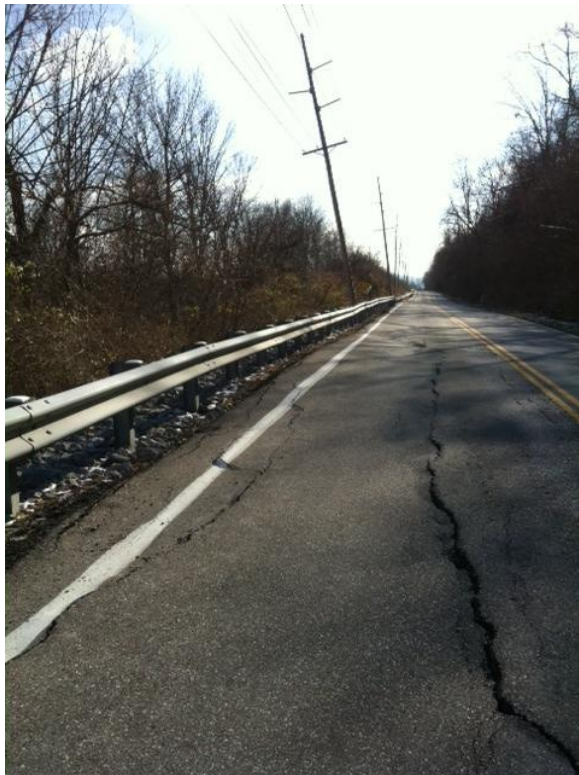
Figure 10: Many of the landslides on the steep slope on the south side of KY-8 have affected the road. These affects can be seen as cracks in the pavement, rolling or bumpy sections of road, and tilted utility poles (Photo by Sarah Johnson).

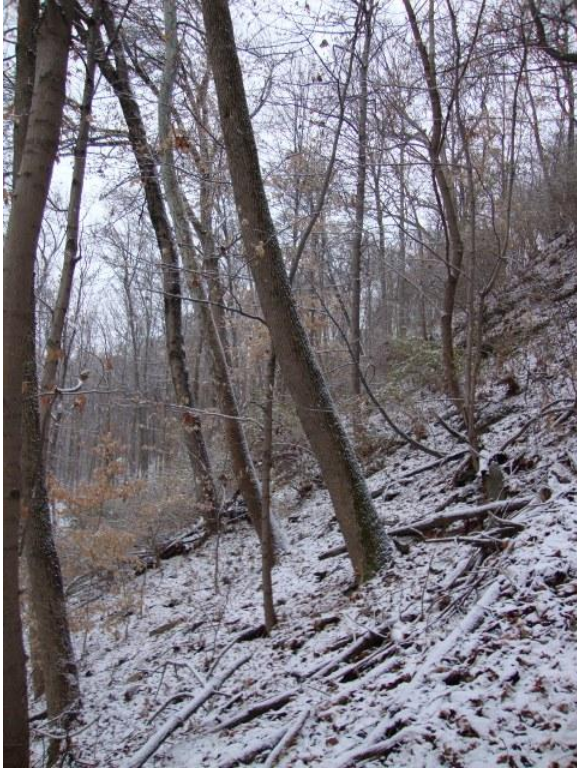
Figure 11: There were tilted trees growing alongside younger straight trees below the scarp-like feature found at Dry Creek. These could be indications that movement has ceased and the landslide is no longer active (Photo by Jesse Amundsen).

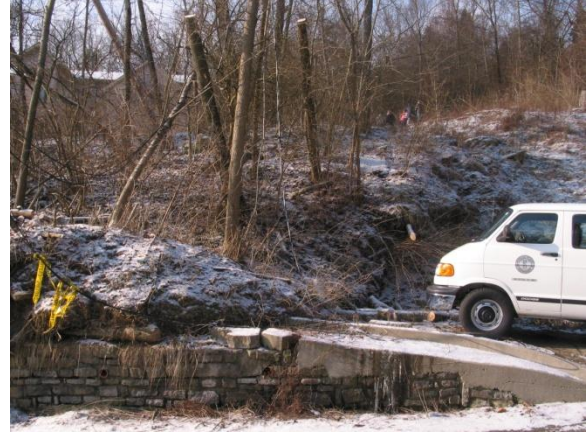
Figure 14: Photograph from 2005 of debris blocking the driveway off of Montague Rd. caused by a translational landslide. The slide was repaired after debris continually blocked the road (Photo by Sarah Johnson).

Montague Rd. passes through Devou Park which is an area recognizable by its high hills and steep slopes. At one location these conditions contributed to the development of a mid-sized translational landslide. The landslide was repaired in late 2009 after it began to rapidly advance which led to the blocking of the driveway of a home nearby (Figure 14). The LiDAR for Northern Kentucky was flown in 2008 before repair work had begun.

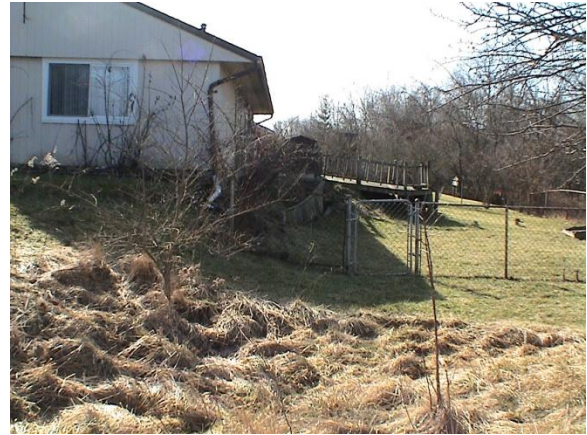
Figure 15: Photograph from 2005 of the backyard of one of the four homes directly affected by the large block extrusion failure at Huffman Ct. in Cincinnati, OH. The deck is shown slipping downwards away from the home indicating substantial movement (Photo by Sarah Johnson).

In order to build a new subdivision on the north end of Cincinnati, development began as early as 1961 near Huffman Ct. off of Compton Rd but was abandoned until the early 1970's when development was reinitiated in order to build a small subdivision of 26 low cost housing units. Up to four housing units have been damaged to some degree by a landslide that developed on the northwest side of the neighborhood. Numerous studies have been conducted on the landslide that conclude that glacial lakebed clays were present and overlaying glacial till with the landslide occurring within them (Fleming R. W., 1981). Despite the fact that the landslide has persisted and continued to affect homes on Huffman Ct. (Figure 15), it has yet to have been properly remediated.

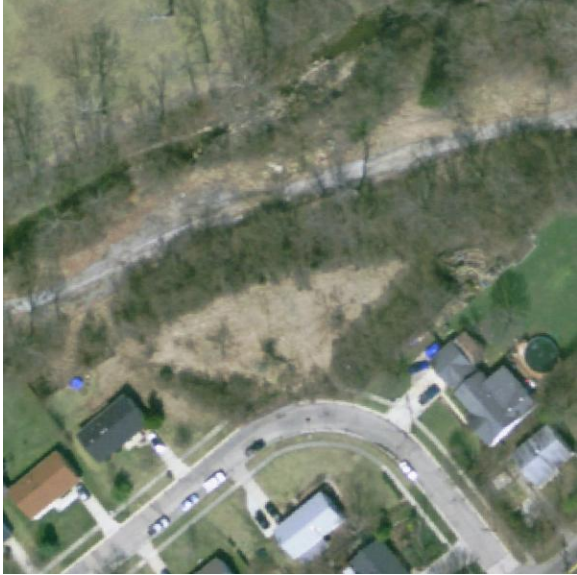
Figure 16: Aerial photograph obtained from the OSIP aerial imagery archive of the landslide located off of Huffman Ct. north of Cincinnati, OH. The top of the slide can be seen affecting the sidewalk on the northeast side of the turn in the road. The gray feature near the bottom of the slide is an access road which is moving with the slide.

There are different interpretations of the sliding process at the Huffman Ct. landslide that involve both rotational and block extrusion mechanisms. Due to the presence of lakebed clays and a non-rotational movement profile it was treated as a block extrusion failure. The slide lacks a well-defined scarp and toe that is typically present in slope and contour maps (Figure 18B; Figure 18D) which also suggests that the failure process may involve movement more typically associated with block extrusions. Lakebed clays were identified in the stream bed channel. The data had a particularly low ground strike return density in the area and there appears to be far less returns on the head and toe of the slide than in the body. This can be seen readily on the curvature map (Figure 18C). Field work discovered that honeysuckle was present in these areas with low ground strike densities. While the landslide presents challenges for identification in the topographic derivative maps, it is easily delineated when using a recent aerial photograph due to its effects on the sidewalk and homes nearby (Figure 16).
